**Appendix B:
Biological Resources Supporting Information**

RE: Biological Evaluation Letter for the property at the Bishop Ranch 6 project site located at the corner of Norris Canyon Road and Camino Ramon in the City of San Ramon, Contra Costa County, California (PN 2511-02)

Tree Assessment

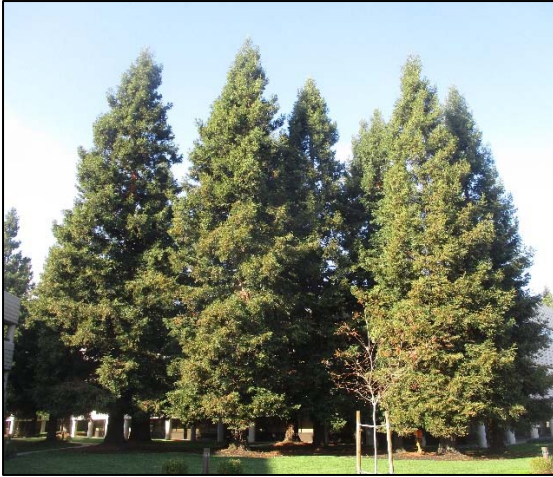
Photo 1 (above). A tightly clustered group of coast redwood was growing on the southern side of 2410 Camino Ramon.

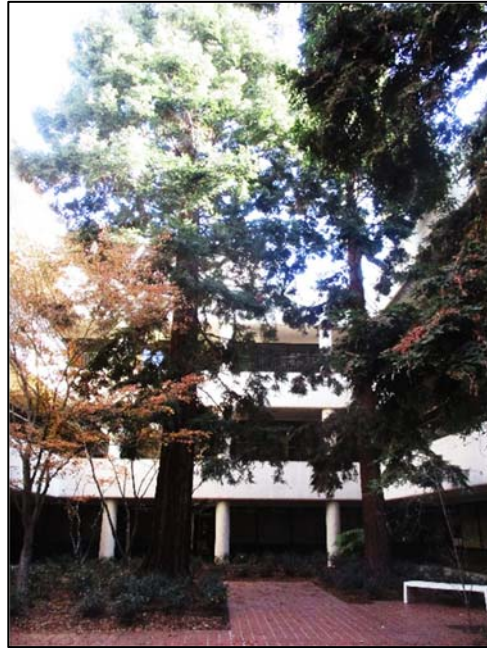
Photo 2 (top right). Coast redwoods were growing in the the interior courtyards of each of the three buildings had health crowns with minimal lower branching.

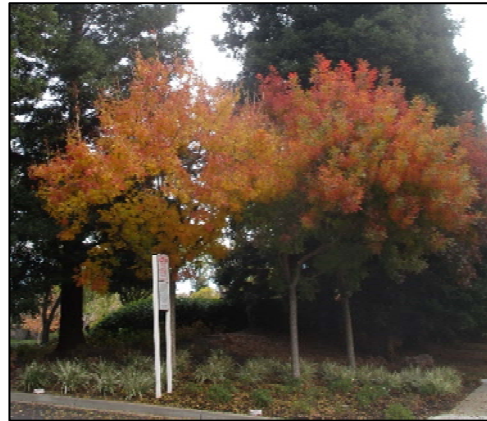
Photo 3 (right). Chinese pistache trees growing at the entrance to the campus from Camino Ramon.

Nine-eight (98) Chinese pistache trees were present. The Chinese pistache were planted at the entrances to the campus in tight clusters (Photo 3). Fifty-three (53) trees were in good condition and 45 were in fair condition. Trees were semi-mature in development with trunk diameters between 6 and 15 inches.

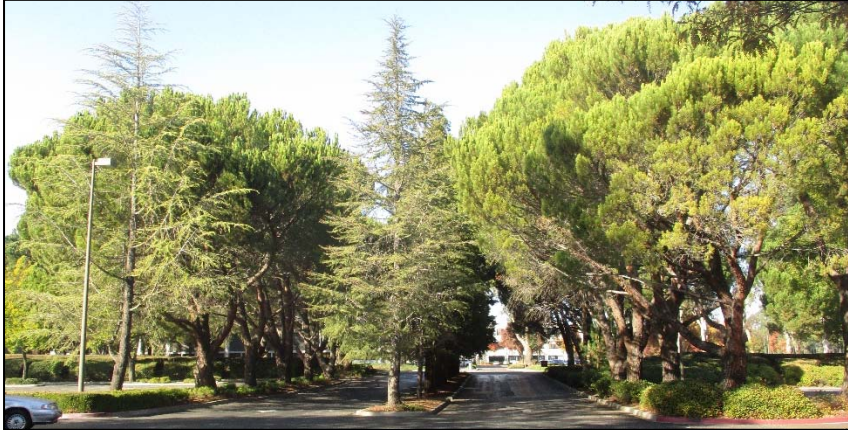
Thirty-six (36) Italian stone pines and one Canary Island pine were evaluated. This group of 37 pines was in good condition with 35 trees with Canary Island pine (#200 and Italian stone pine #96) in fair condition. The Italian stone pines were planted in allees along the entrances on the north and south sides of the site. The pines were planted in close proximity to each other, leaving limited growth space above and below ground (Photo 4, next page).

Photo 4. Italian stone pines (#46 – 58 and 70 – 74) were along the parking lot entrance off Norris Canyon Road.

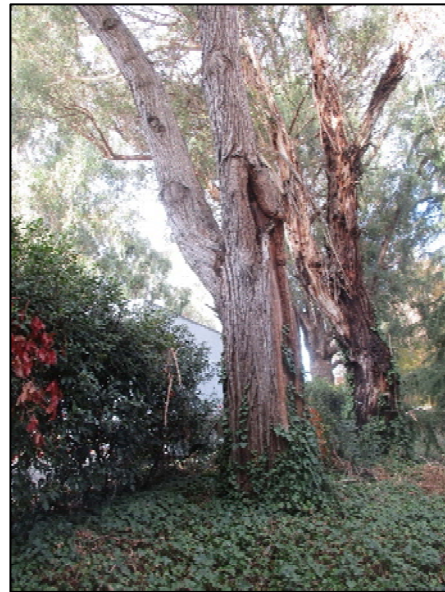
Twenty-three (23) Nichol's willowleafed peppermint were growing exclusively on the slope between properties on the northwestern edge of the site. This group of trees varied in condition with six trees in good condition, nine in fair condition and eight in poor condition. Trees ranged in size from 13 to 48 inches in diameter. Nichol's willowleafed peppermint #653 had a large cavity from 1 to 15 feet, included bark in the attachment, and decay. Tree #654 had burn wounds on the trunk (Photo 5).

Photo 5. Nichol's willowleafed peppermint #653 had a large cavity from 1 to 15 feet on the east side of the tree. Tree #654 had burn wounds on the trunk.
