**DOUGHERTY VALLEY**  
**TREE AND PLANTING STRIP**  
**MANAGEMENT PLAN**

**San Ramon, CA**  
September 2017

**San Ramon City Council**

**CALIFORNIA TREE AND LANDSCAPE CONSULTING, INC.**

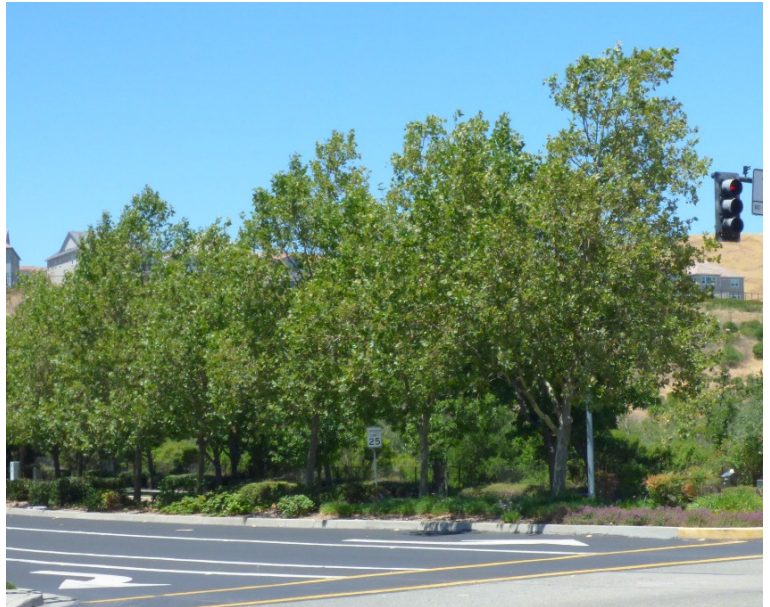
**Photo 1.** Trees growing alongside Bollinger Canyon Road

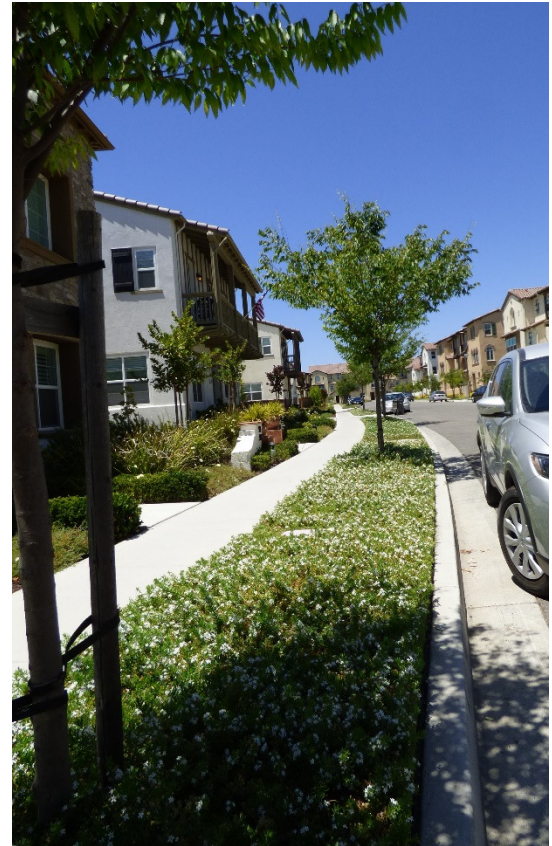
**Photo 4.** Low Water use ground cover in a 4' wide planter strip.

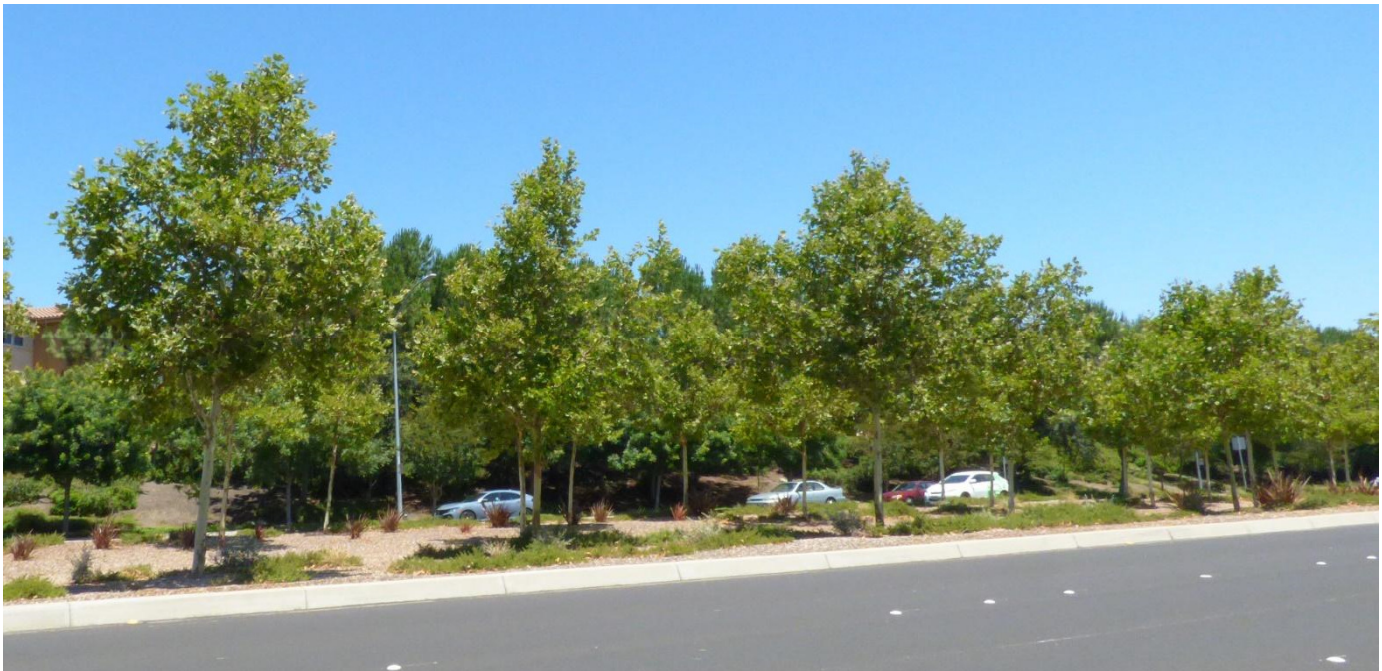
**Photo 6.** Bollinger Canyon Road median, containing London Plane trees with adequate growing space. The trees are healthy and growing vigorously. The under planting has recently been replaced.

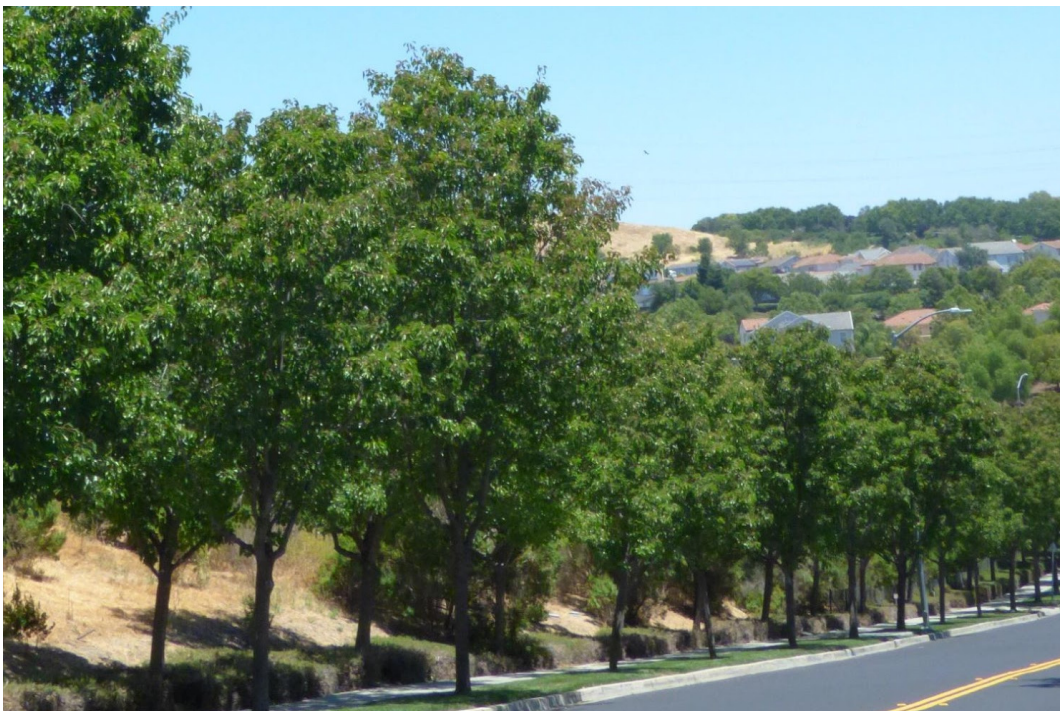
**Photo 7.** Ornamental Pears growing in a 7’ wide planter strip along Bollinger Canyon Road.

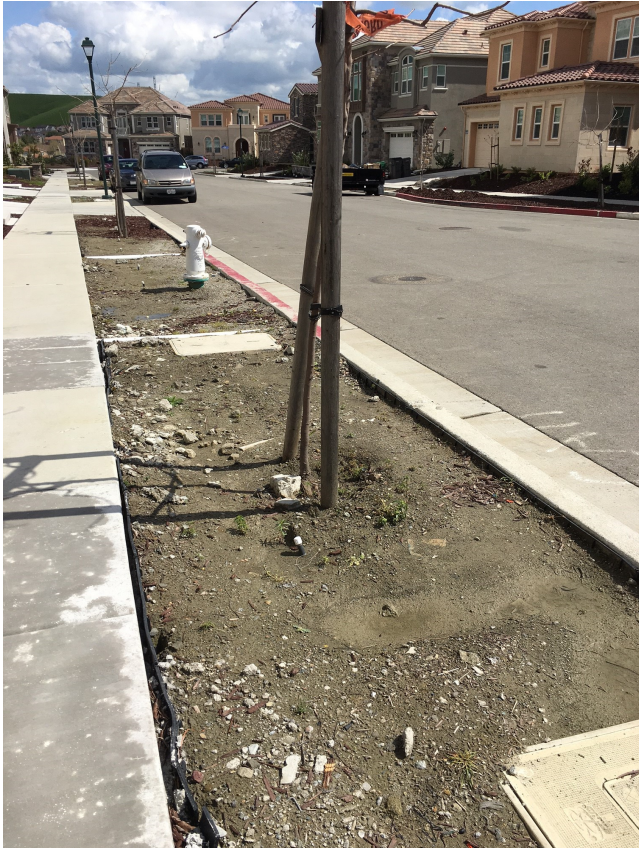
**Photo 8.** Trees planted in Dougherty Valley in the spring of 2017. The soils are compacted and construction debris is present.

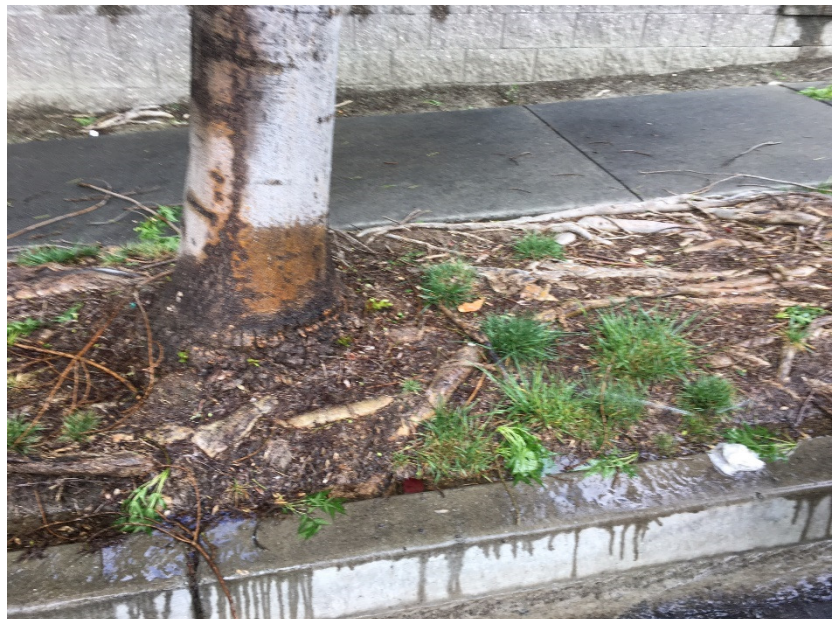
**Photo 7.** An ash tree that has inundated the planting strip, broken the irrigation and is clearly too large for the space allotted.

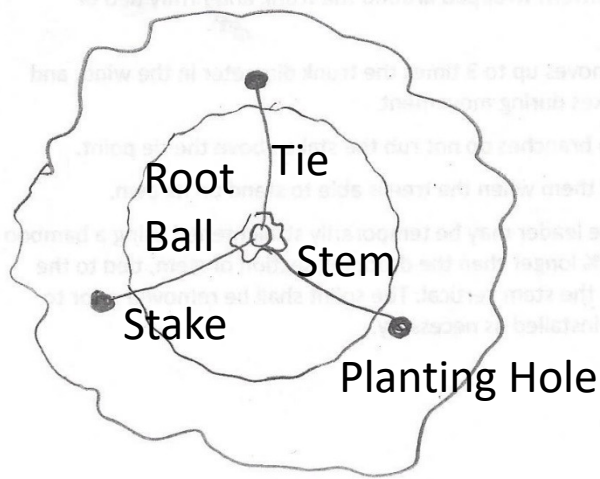
Three Stake Detail Top View

- 5.1 Remove the nursery stake (the thin stake tied to the trunk) that is secured to the tree.
- 5.2 Install the appropriate number of stakes – for example, two stakes on the windward and leeward side of the tree, set at least 2 feet into the native soil outside the root ball.
